Montgomery County Special Protection Area Program Annual Report - May 2001

SPECIAL PROTECTION AREA PROGRAM 2000 ANNUAL REPORT

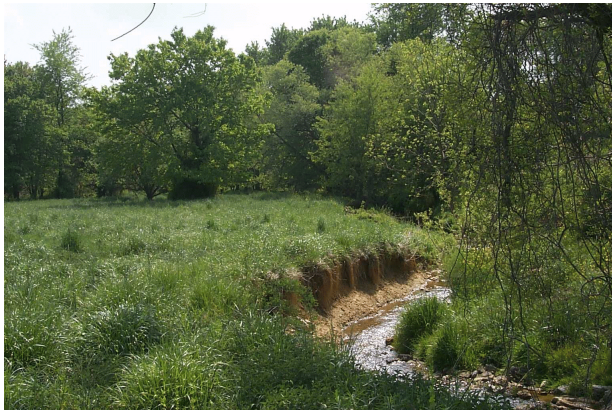
Photo 1. Lack of forested riparian buffer at LSLS203, Photo 2. Sparse forest cover in riparian buffer at

LSLS205, upstream of Rt. 355

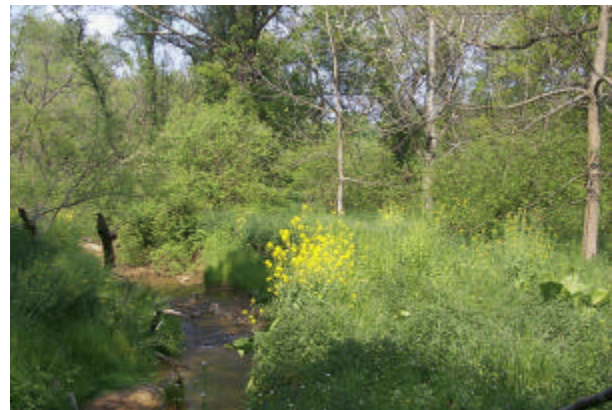
downstream of Skylark Rd.

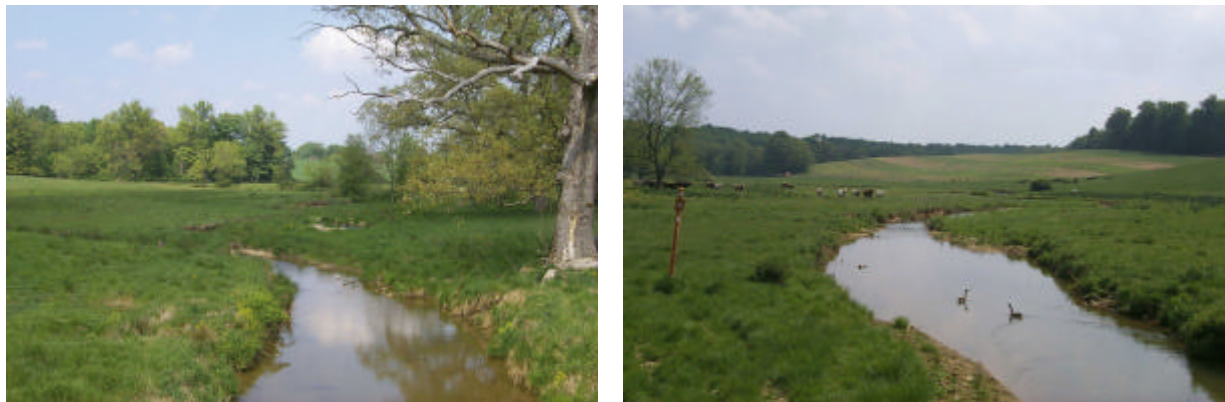
Photos 3 and 4 show the absence of any forested buffer along Little Seneca Creek in the vicinity

of West Old Baltimore Rd (LSLS302). Presently, there are no plans for development which would result in reforestation of the buffer. DEP will work with Montgomery Soil Conservation District and land owners to explore the possibility of reforestation along the stream buffer.

Much of the Little Seneca Creek mainstem, between stations LSL301 and LSL303 has little or no wooded riparian area and consequently no shading to keep water temperatures low during the summer months (see photos 3 and 4). We have documented a decline in biological condition (excellent to fair for benthic macroinvertebrates) between these stations and have theorized that one of the causes is increased water temperatures. Temperature monitoring during the summer of 2000 was set up to address the question.

In summary, results from temperature monitoring during the summer of 2000 show that considerable warming occurs between station LSLS301 (Rt. 355) and LSLS303 (Rt. 270). Most of the warming occurs between stations LSLS301 and LSLS302 (West Old Baltimore Rd.) due to the water passing through shallow braided channels, beaver ponds and open buffer areas. Additional warming occurs downstream between stations LSLS302 and LSLS303 due to a long run (approximately 0.25 miles) through open pasture land (Photos 3 and 4). DEP will investigate the feasibility for reforestation of this area.

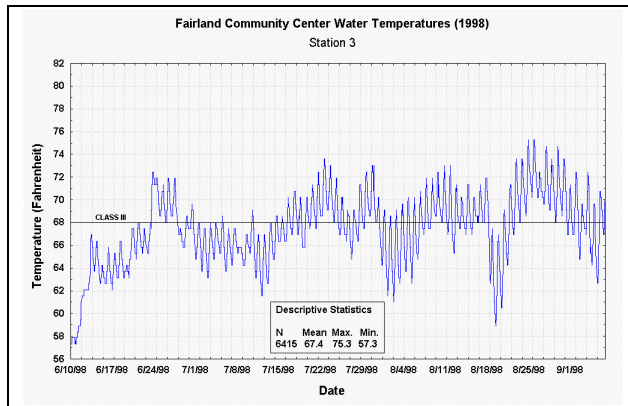
Figure 24. Water Temperatures from Fairland Community Center During 1998

Continuously recording water temperature loggers are deployed in the stream receiving runoff from the Fairland Community Center. Findings from this monitoring indicate that water temperatures, during summer months, are frequently above the sixty-eight degree standard for Use III streams (Figures 24, 25 and 26). Water temperatures were over the 68 degree standard 63% of the time they were monitored during the last three summers. Temperatures frequently exceeded the standard for long continuous periods of time also. In 1999 temperatures were over the standard for a continuous period that exceeded 19 days. This was a drought year however. The longest continuous period over the standard exceeded eight days in 1998. Temperatures were above the standard for a continuous period of over eight days in 2000 also. Maximum temperatures were 75.3 degrees in 1998, 81.7 degrees in 1999 and 80.6 degrees in 2000. Average water temperatures during 1998, 1999 and 2000 were 67.4 °F, 71.9 °F and 70.1 °F respectively. Water temperatures have been higher for two years following the pre-development monitoring of 1998. Summer of 1999 was very hot and dry which would explain the warmer temperatures. However, summer of 2000 was relatively cool and wet but average temperature was still three degrees warmer than 1998.

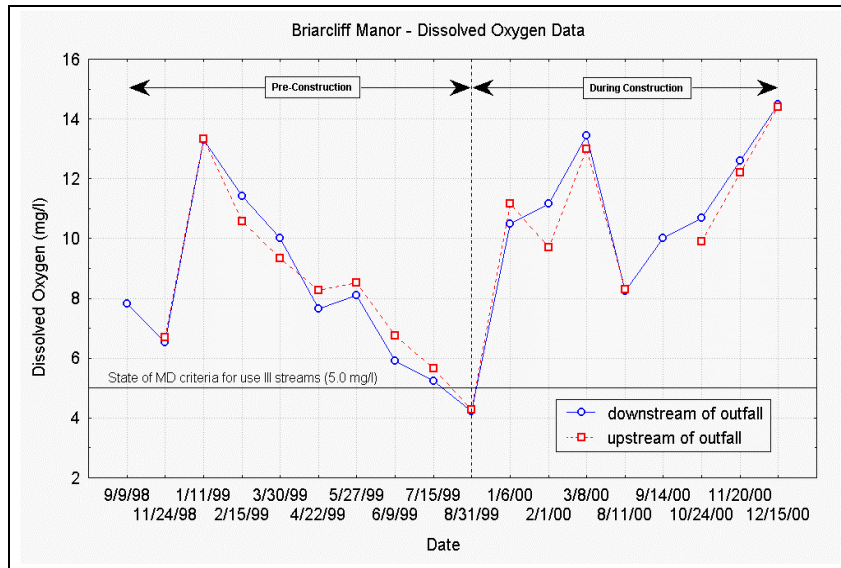
Figure 29. Dissolved Oxygen Readings from Briarcliff Manor

Water quality readings (dissolved oxygen, pH, conductivity, temperature) are taken at the same two locations as embeddedness. The purpose of this monitoring is to determine if water quality is impacted by outfall from the stormwater management pond. Dissolved oxygen data obtained thus far are presented in Figure 29. Dissolved oxygen levels dropped below the State of MD criteria of 5.0 mg/L during August of 1999. Low dissolved oxygen readings taken here and at other locations in the Paint Branch watershed during this period are considered drought related. Other water quality parameters (pH, conductivity) have shown no difference, either between stations or before and during construction.

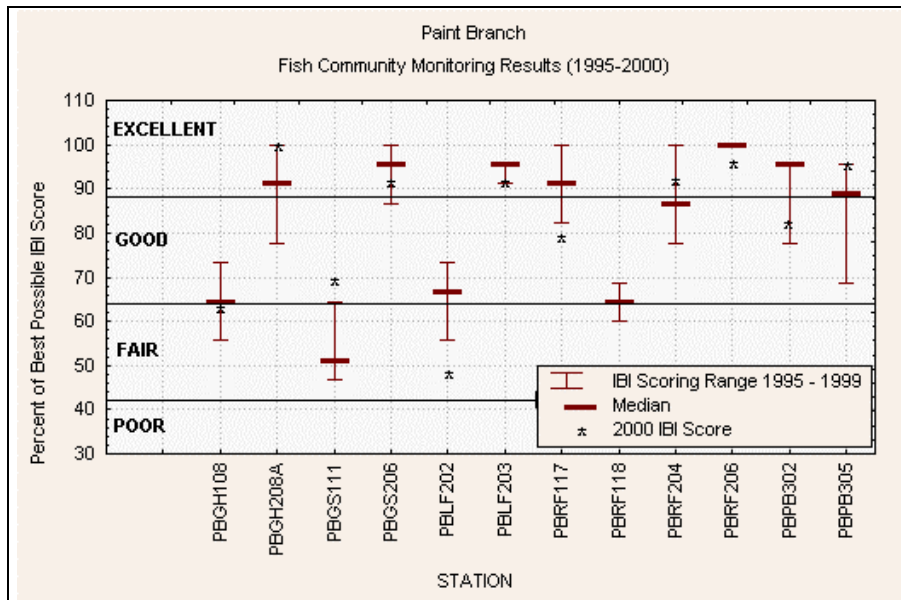
Fish sampling was completed at eleven stations during 2000. Results (Figure 31) suggest that the drought of 1999 had little impact on the fish community as a whole. However, numbers of Brown Trout adults and young-of-year were lower throughout the watershed. The Right Fork was particularly hard hit as Brown Trout were absent from all stations sampled (PBRF117, PBRF204 and PBRF206) for the first time since monitoring began in 1994. The rest of the fish community has remained intact. Because the IBI is meant to indicate the status of the fish community as a whole, the lack of Trout alone does not affect IBI scores greatly. IBI values at these three Right Fork stations remain comparable with previous years (Figure 31). Two stations (PBRF117 and PBLF202) experienced declines in IBI scores due to lower numbers of fish species that occupy the riffle habitat. These two stations are located in the upper portions of the Right Fork and Left Fork where stream flows were down to a trickle during the summer of 1999.

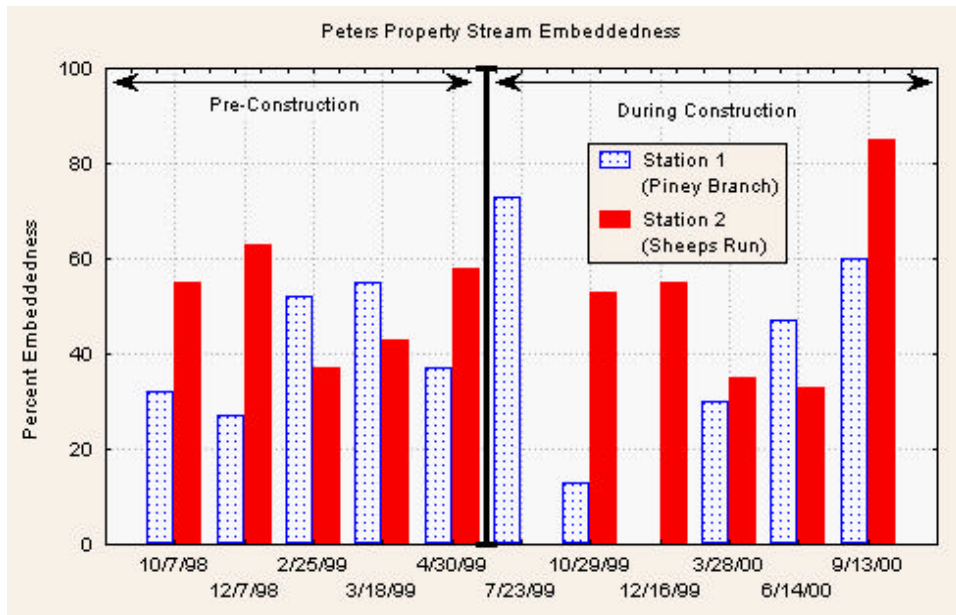
Embeddedness data from the Peters property indicates episodic increases in sedimentation since construction commenced (Figure 47). Embeddedness values obtained since construction commenced have generally been comparable to values observed prior to construction. However, in both streams, embeddedness has on occasion been higher than before construction. On July 23, 1999 embeddedness in Piney Branch was measured at 73%. The highest value observed during the pre-construction period was 55%. On September 13, 2000 embeddedness in Sheeps Run was measured at 85%. The maximum embeddedness value observed in Sheeps Run prior to construction was 63%.
