TECHNICAL REPORT

Upper Paint Branch

WATERSHED PLANNING STUDY

The Maryland-National Capital Park & Planning Commission
Montgomery County Planning Department

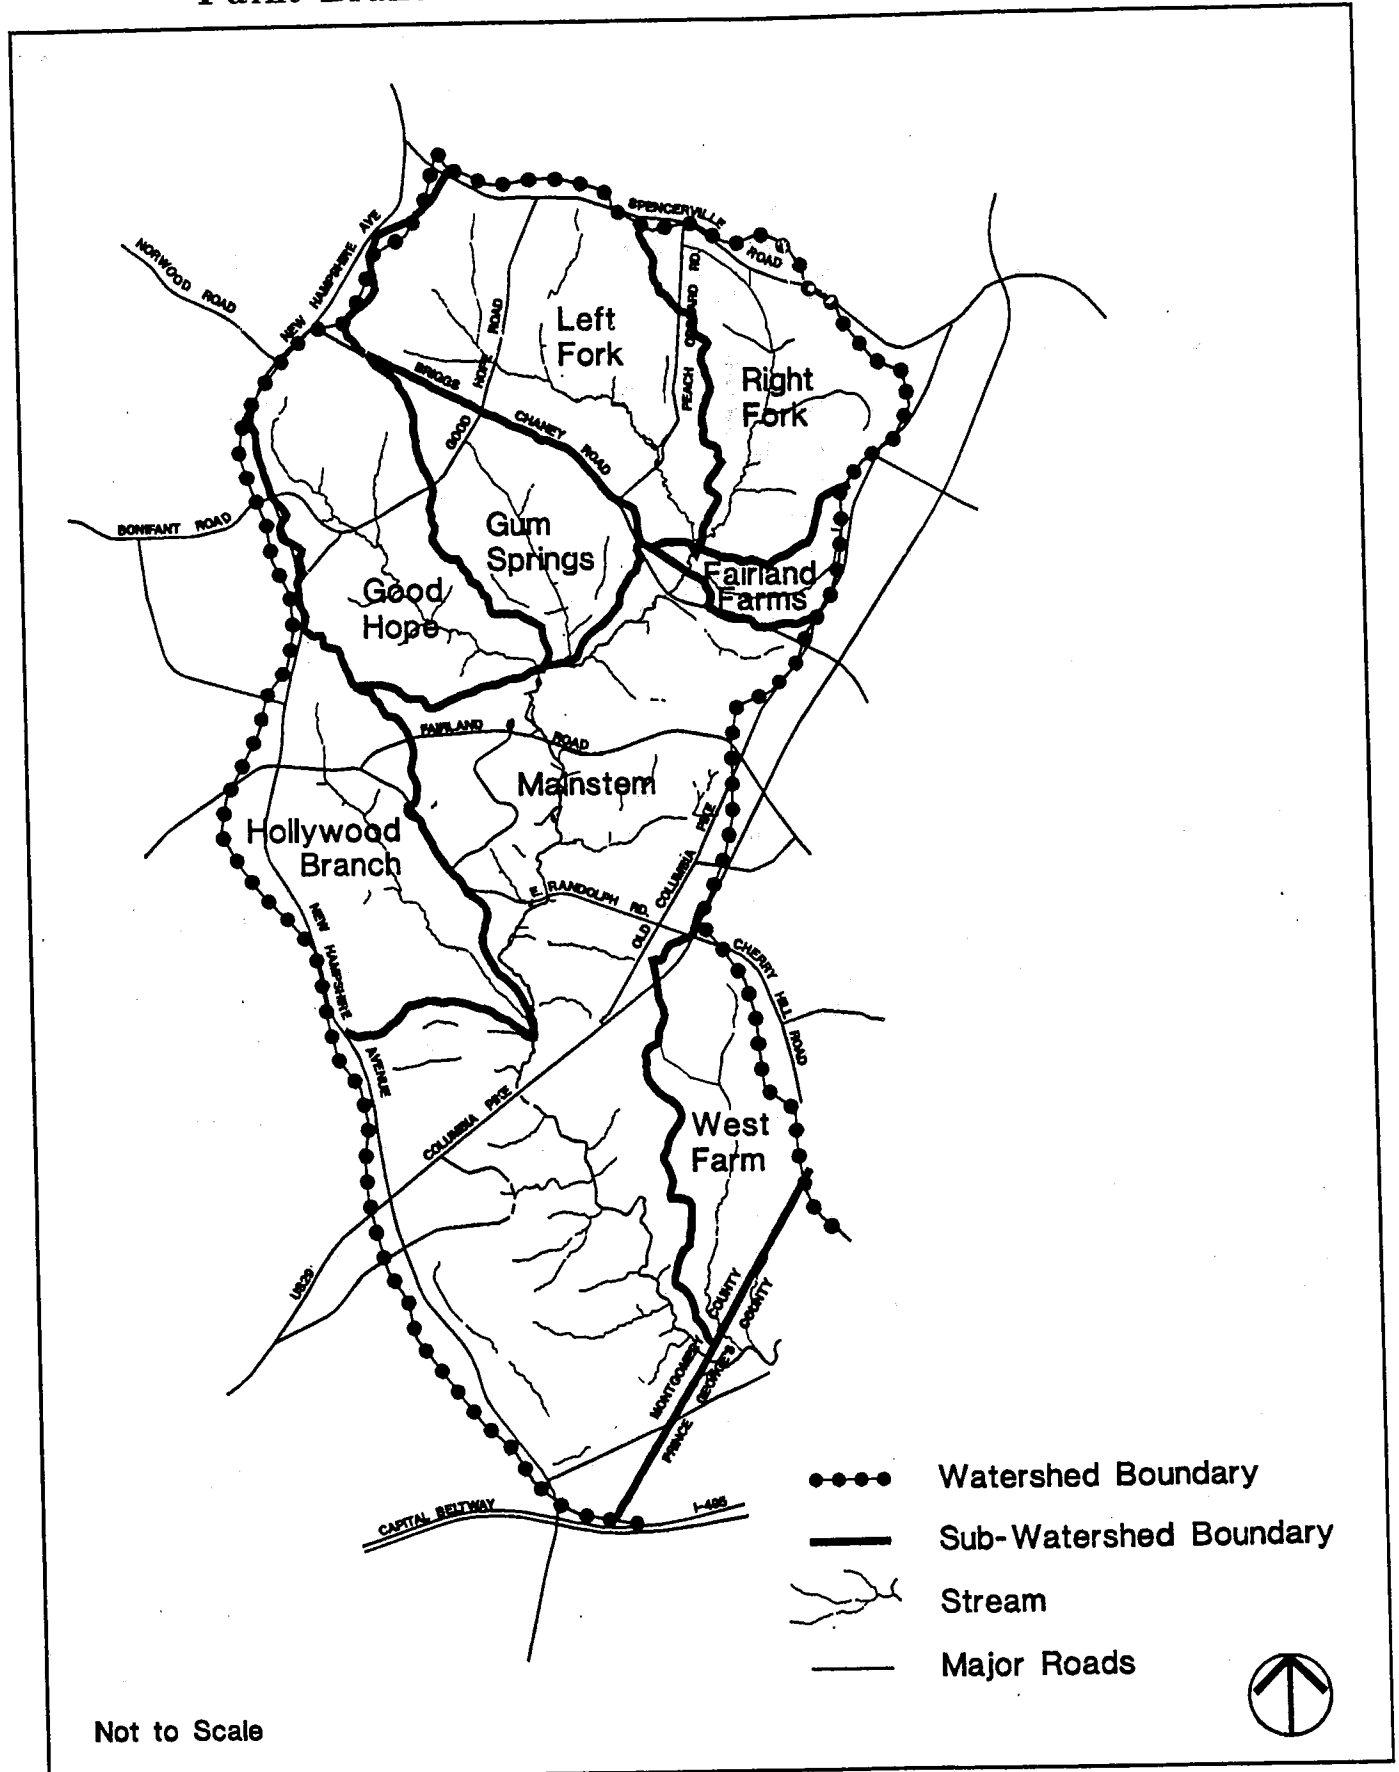
Figure 1

Paint Branch Subwatersheds Defined for the Study

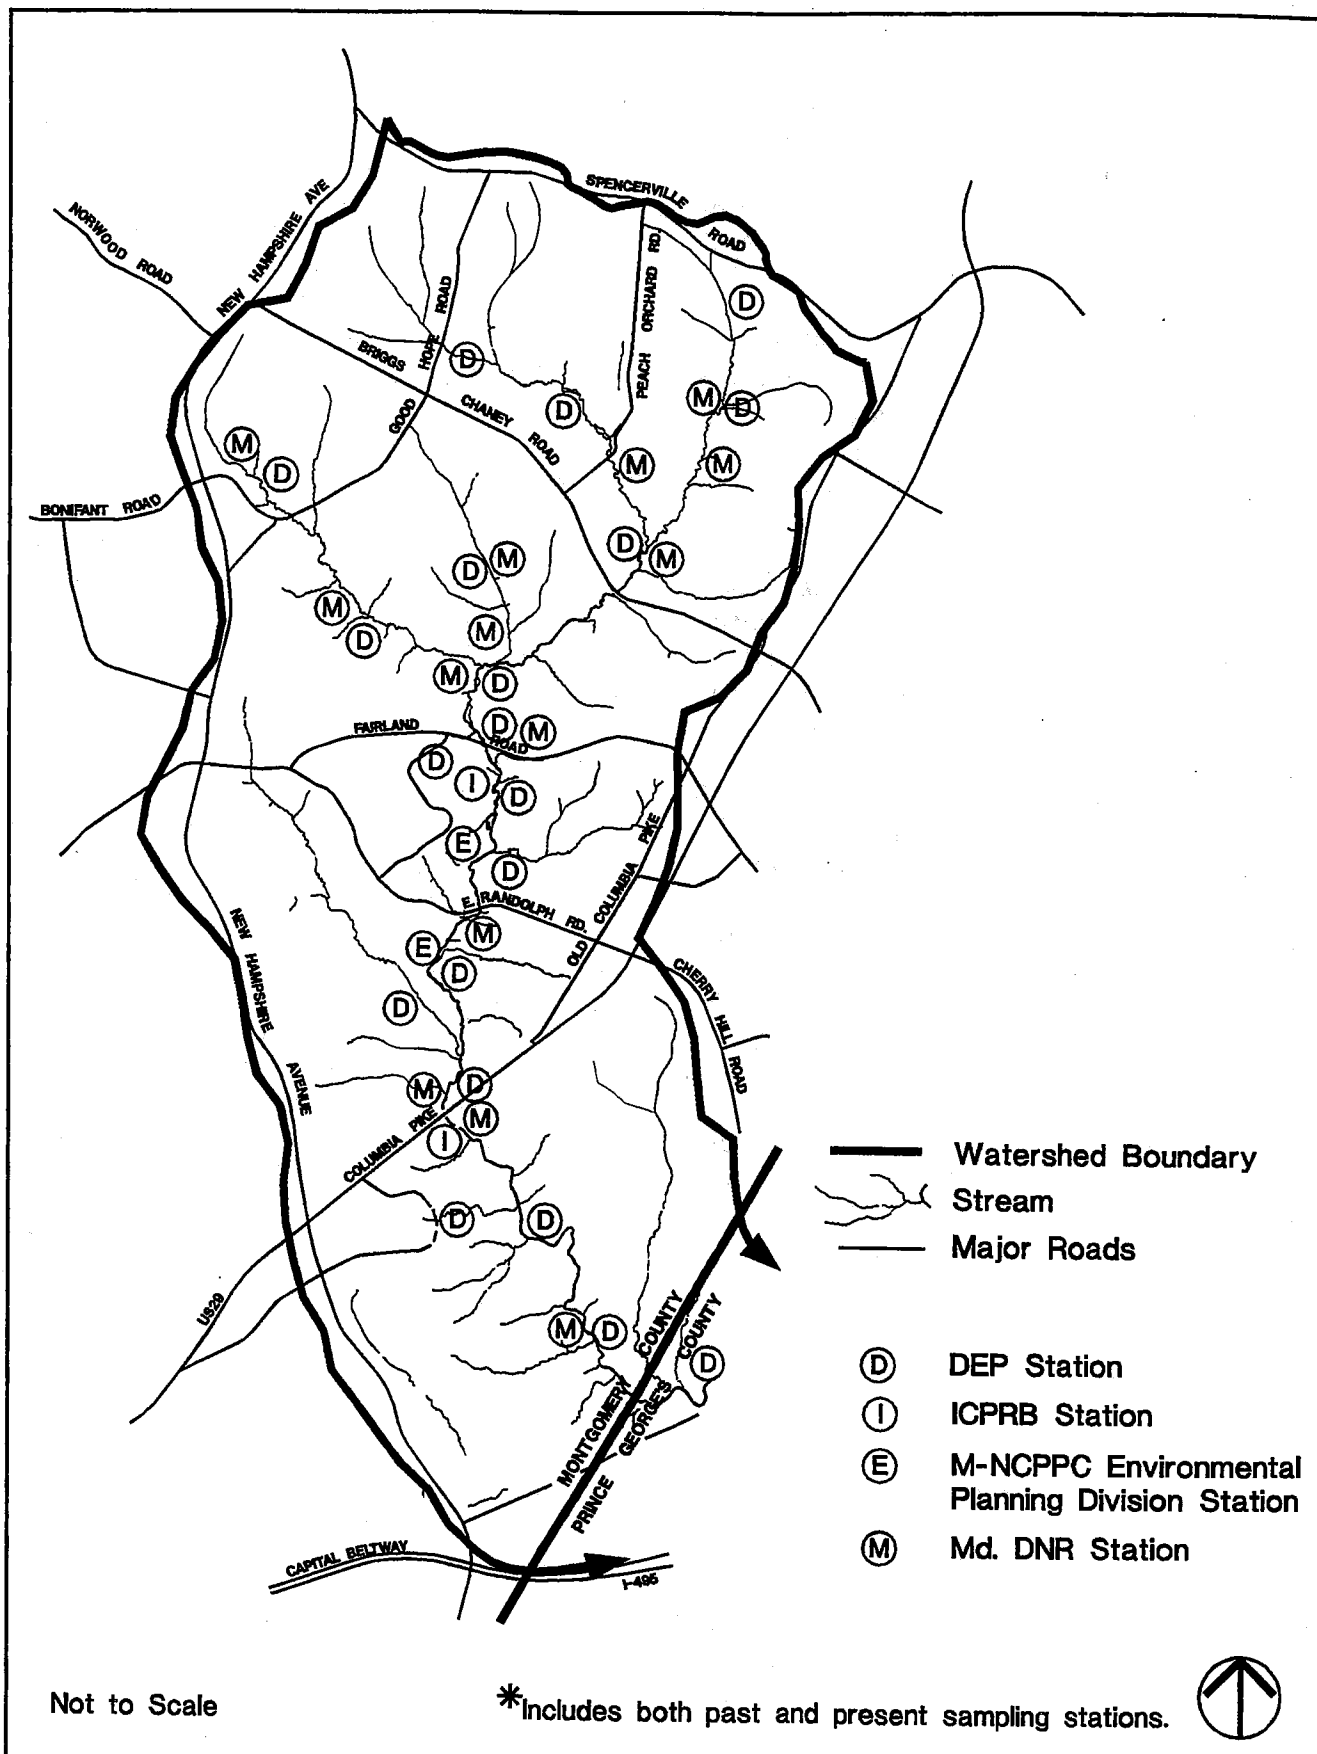
Figure 1

Paint Branch Stream Sampling Stations

Within the subwatersheds, the study has collected limited information on aquatic macroinvertebrate communities and stream habitat conditions in areas where no consistent monitoring has been done in the past in order to better characterize existing conditions. M-NCPPC Environmental Planning Division staff collected data on macroinvertebrates and stream habitat conditions at two stations using the Rapid Bioassessment Protocol II developed by the U.S. Environmental Protection Agency (Plafkin et al., 1989). A modified and more rigorous version of this methodology for assessing stream quality is being used by DEP in their stream monitoring program.

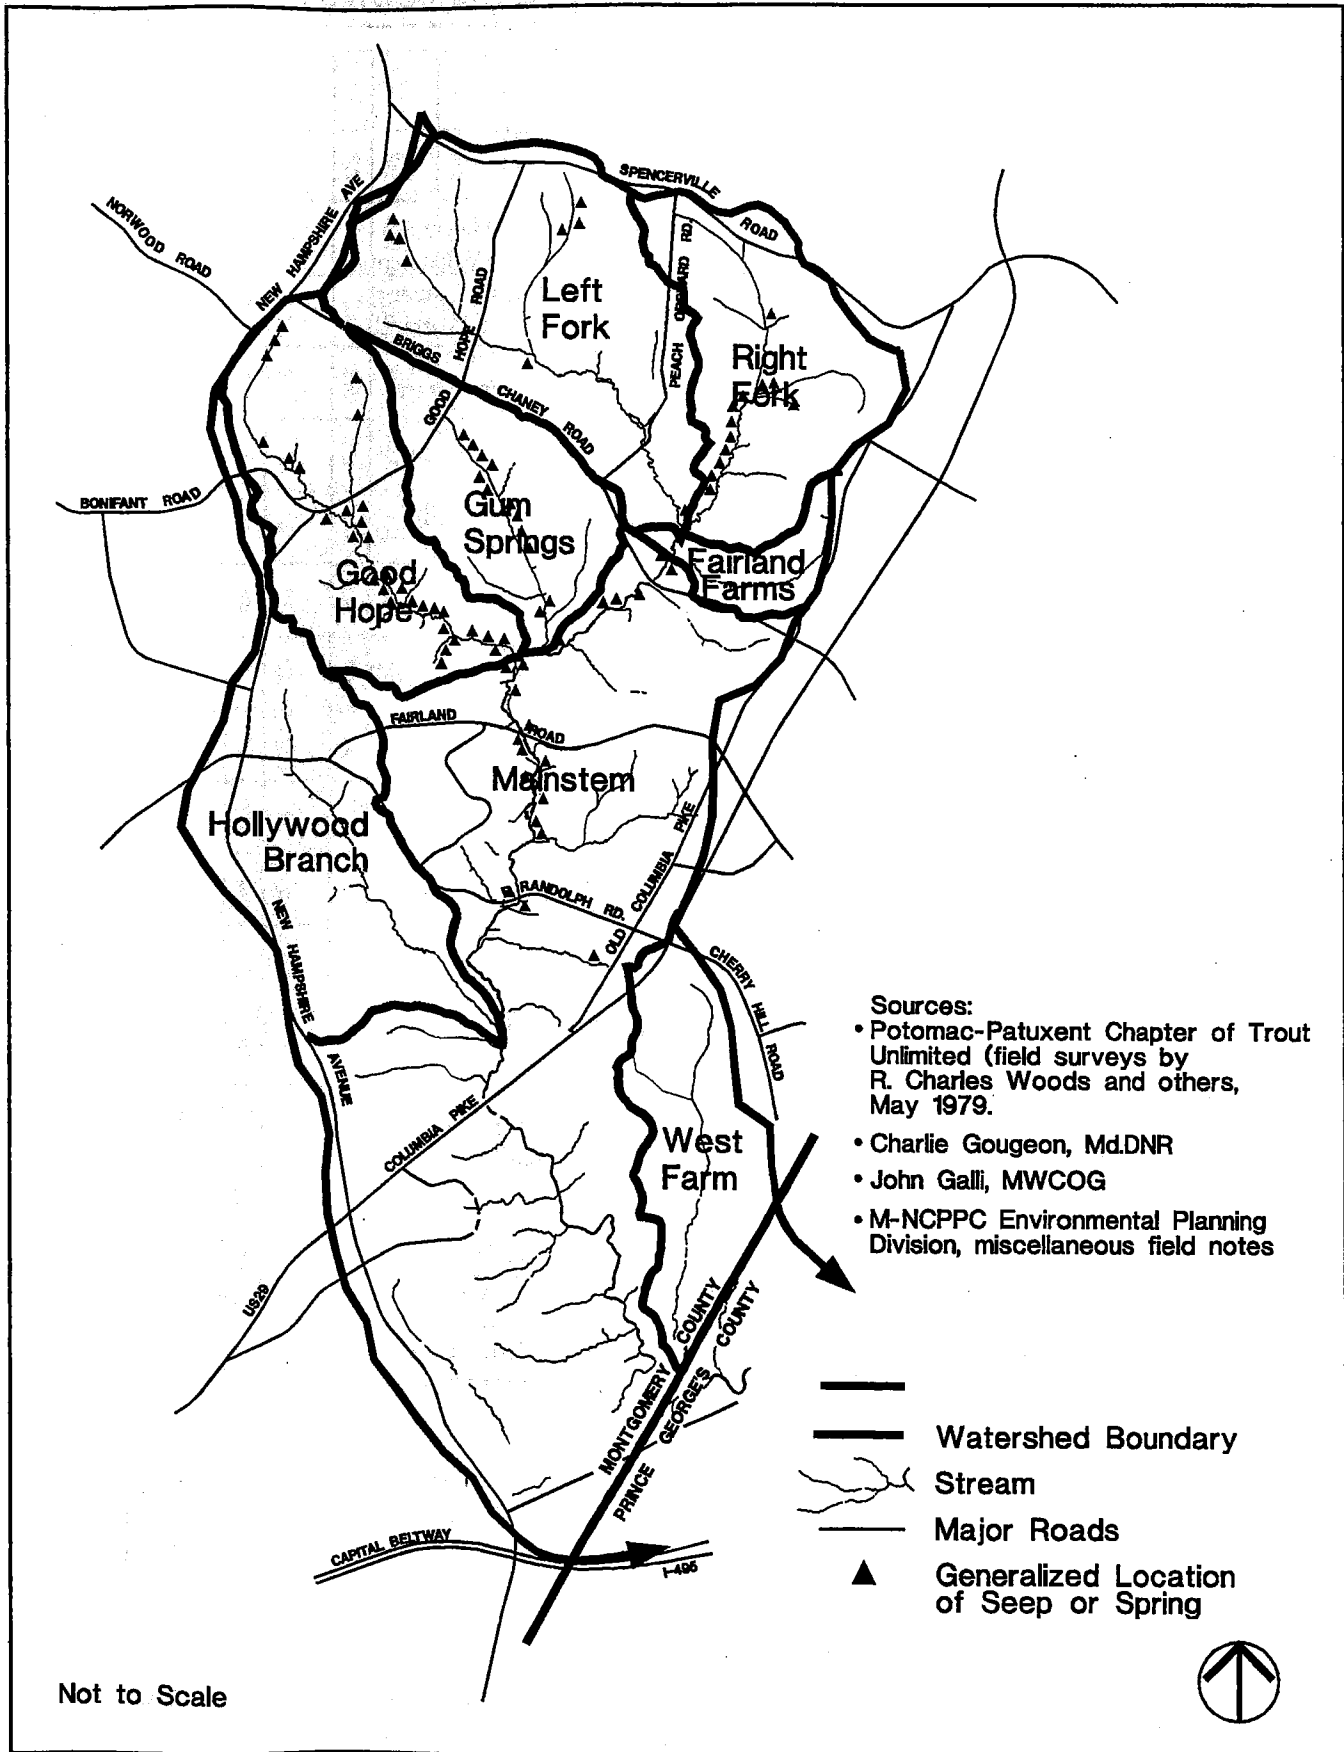
Figure 4

Generalized Locations of Large Seeps and Springs

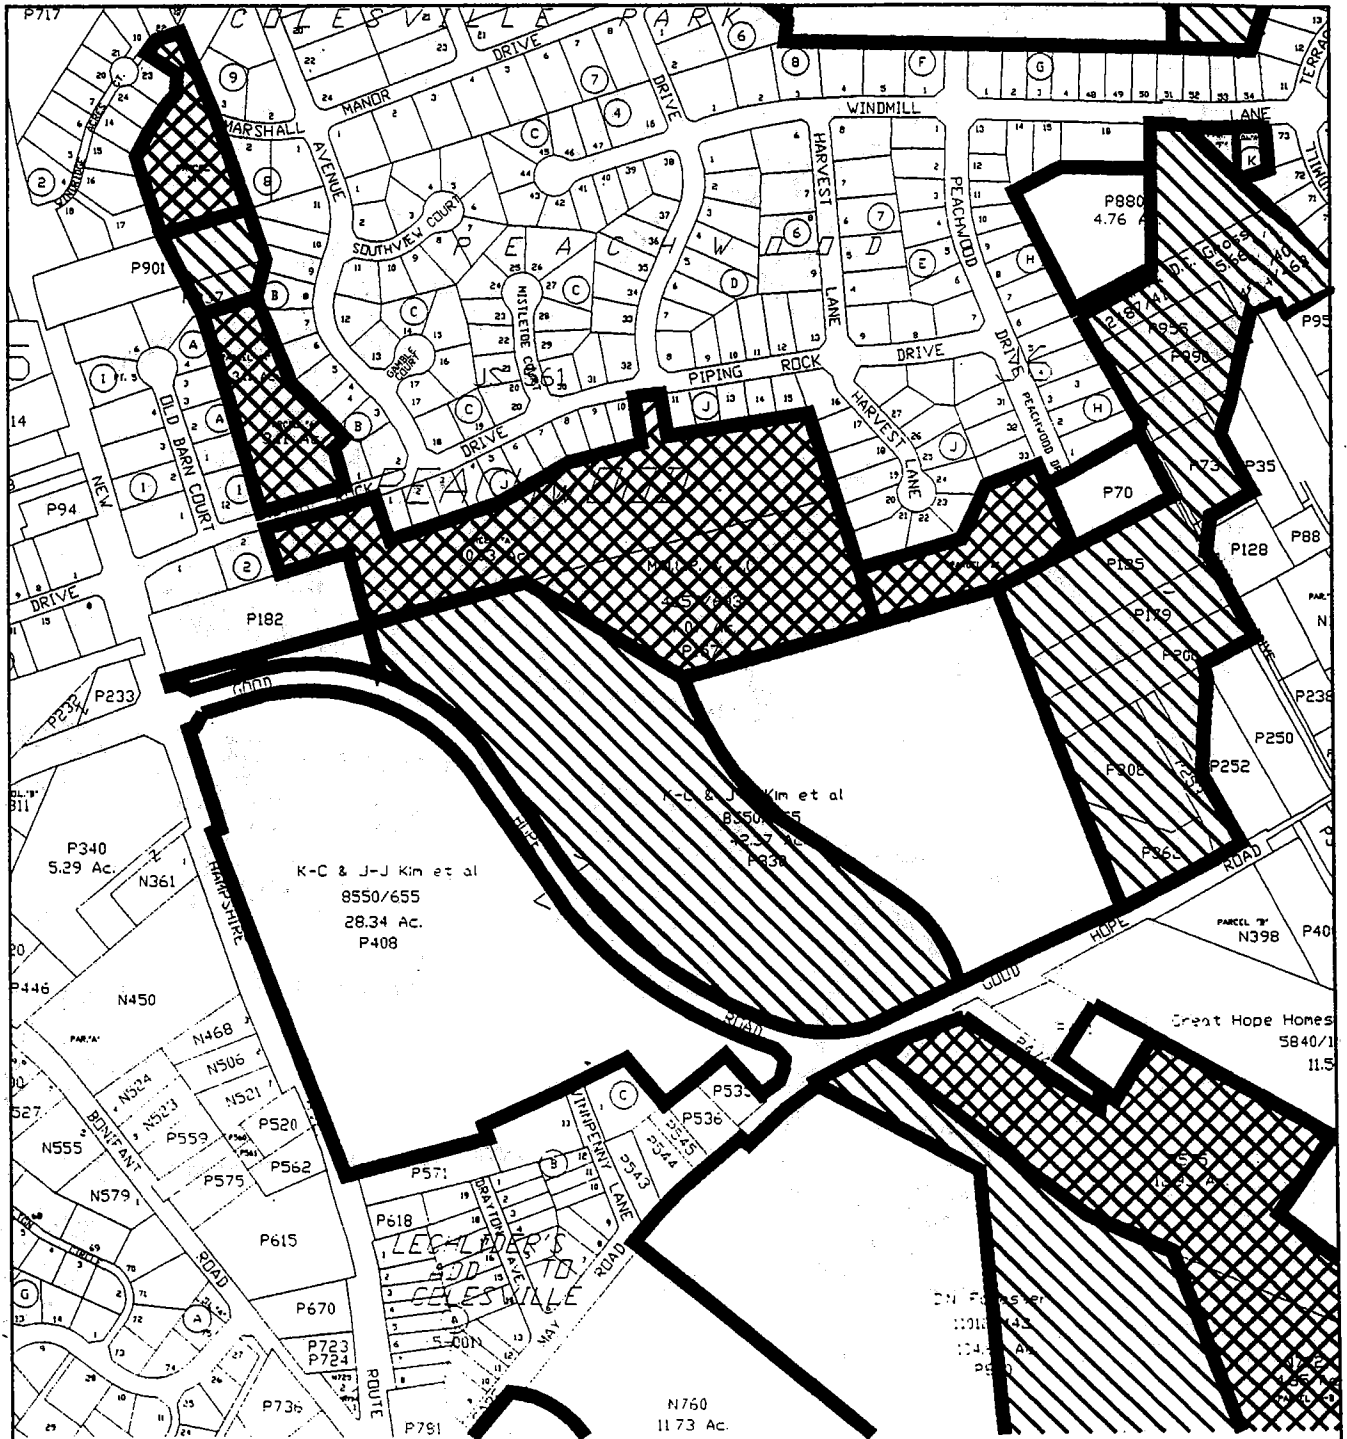
Map 2

Proposed Expanded Park Acquisition in the Upper Paint Branch Watershed

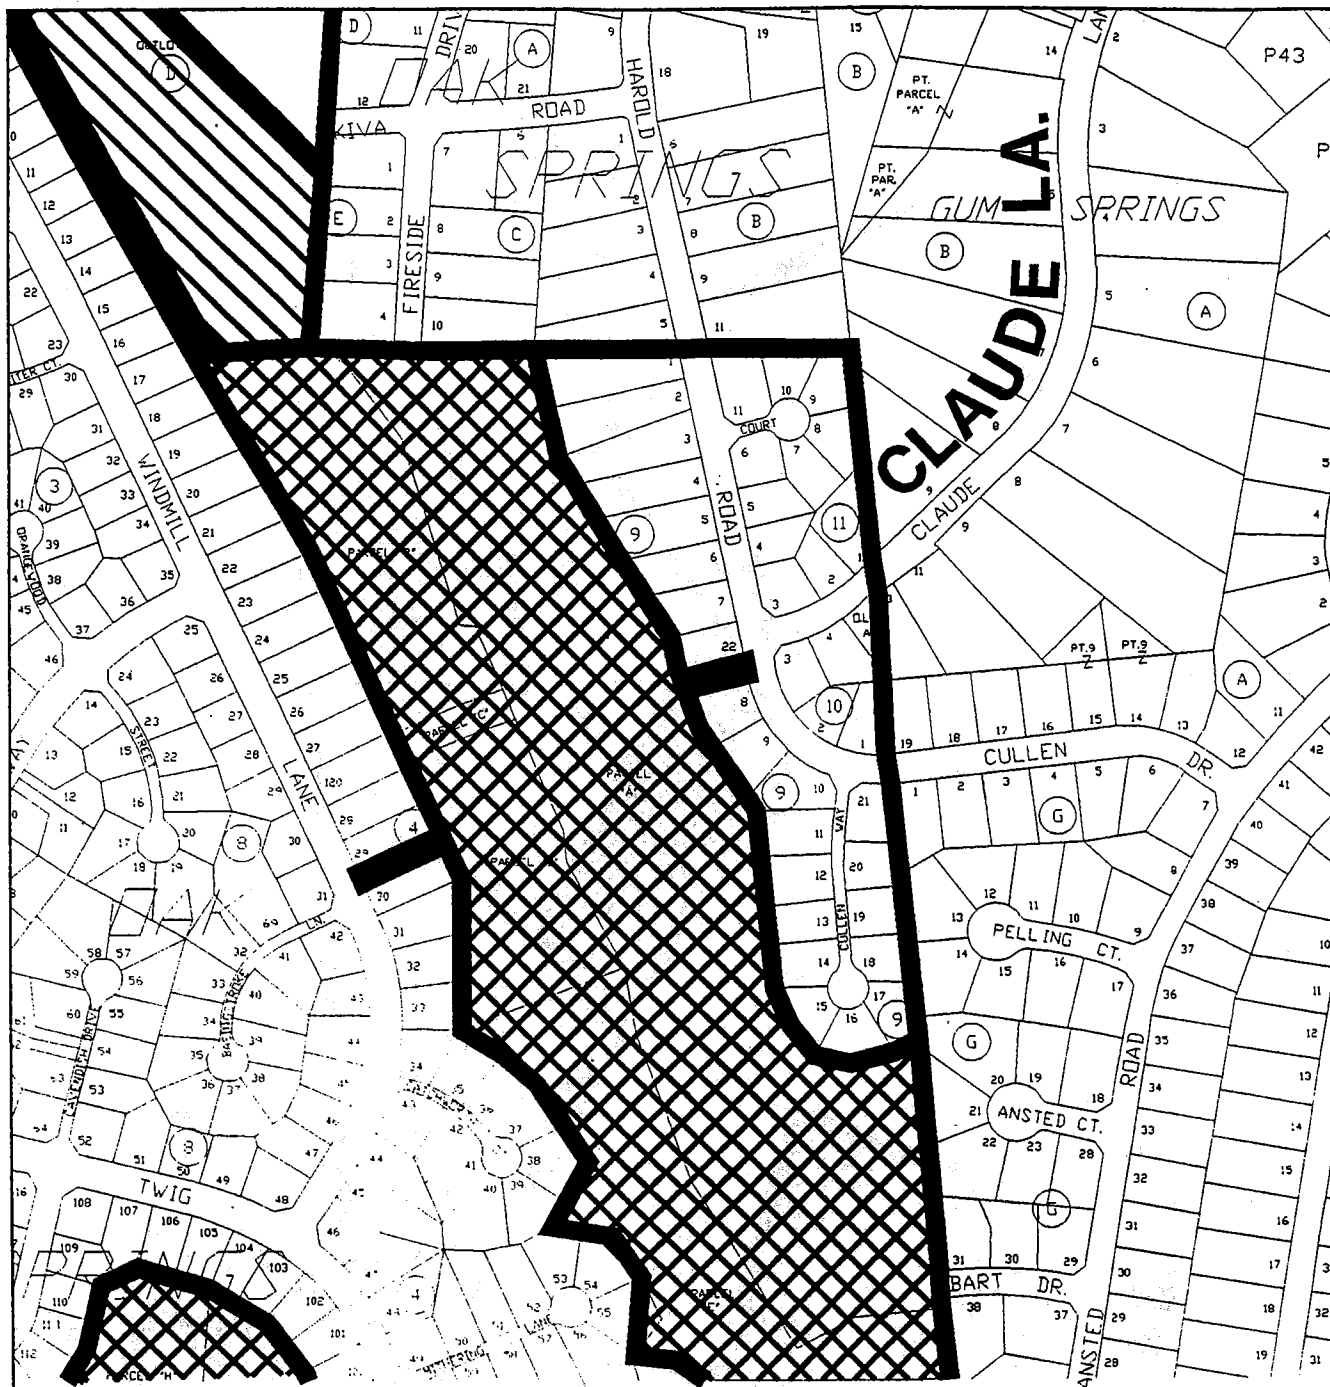
Map 6

Proposed Expanded Park Acquisition in the Upper Paint Branch Watershed

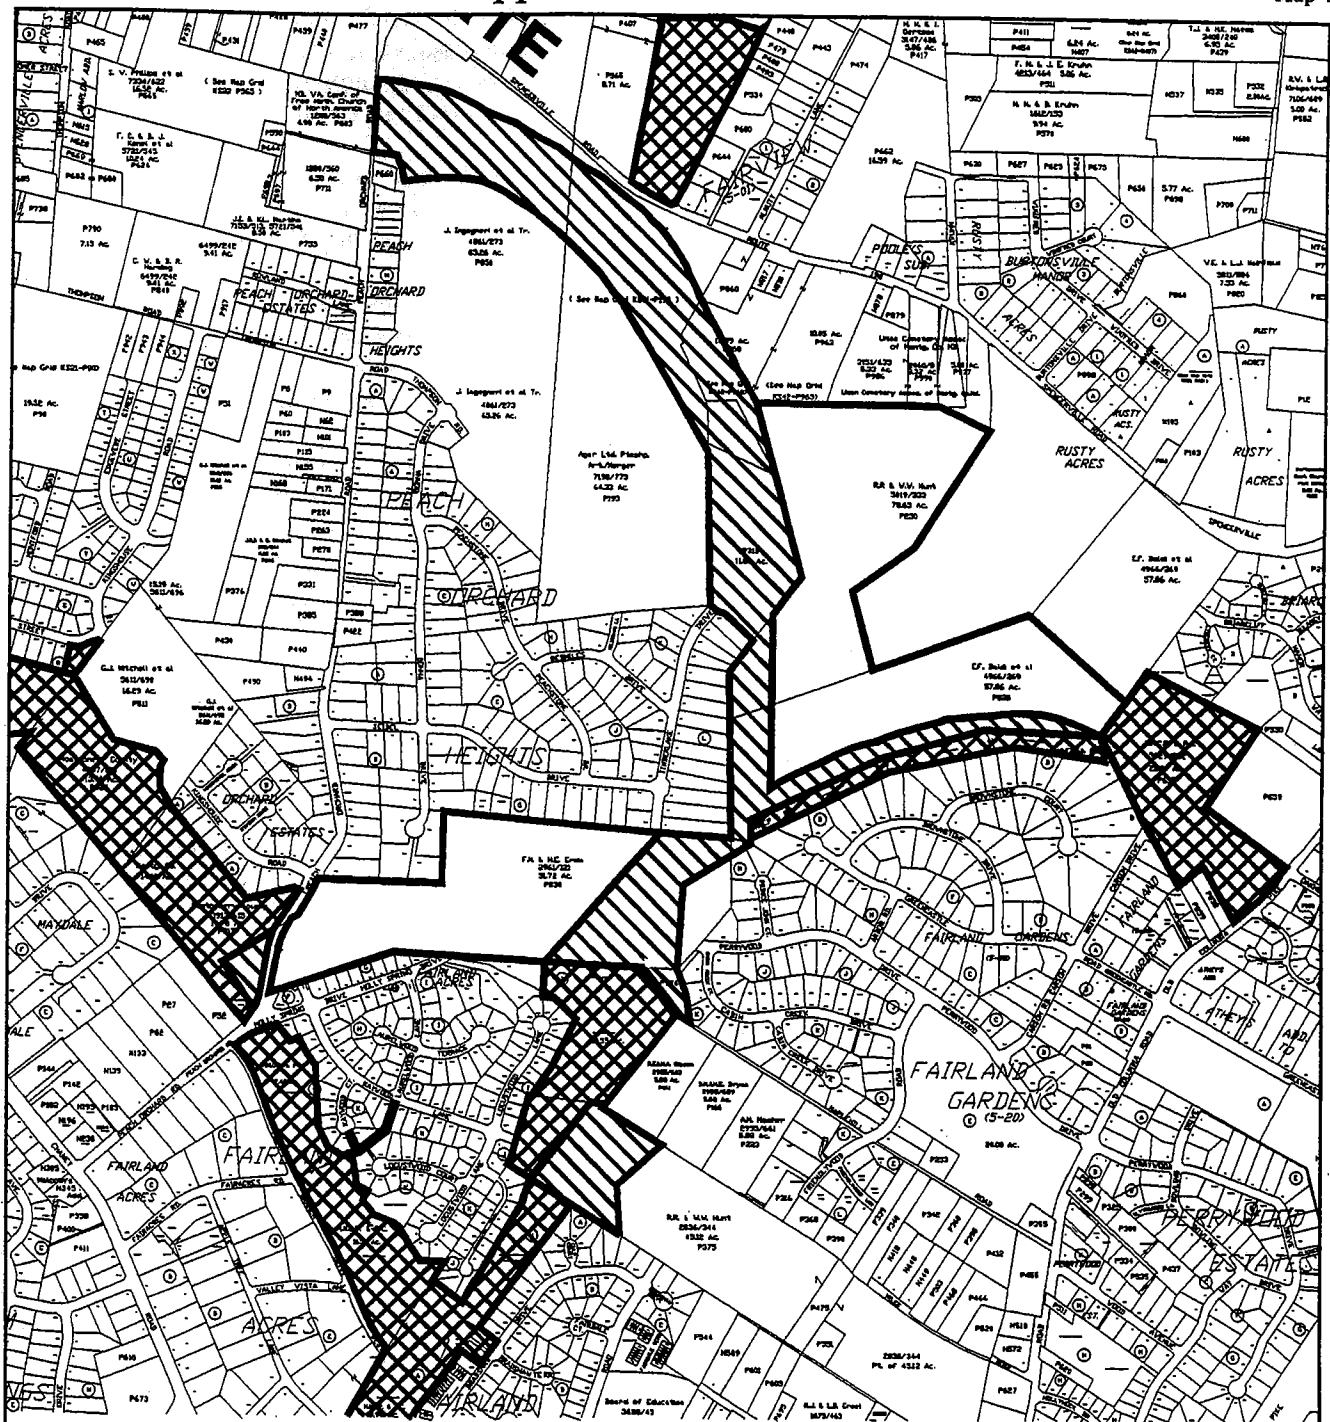
Map 9

Proposed Expanded Park Acquisition in the Upper Paint Branch Watershed
